MICHIGAN DEPARTMENT OF CONSERVATION
Game Division

A Preliminary Study of Waterfowl Flooding Projects
in Region II. Summer 1951

(An extract of Game Division Report #1150
of the same title)

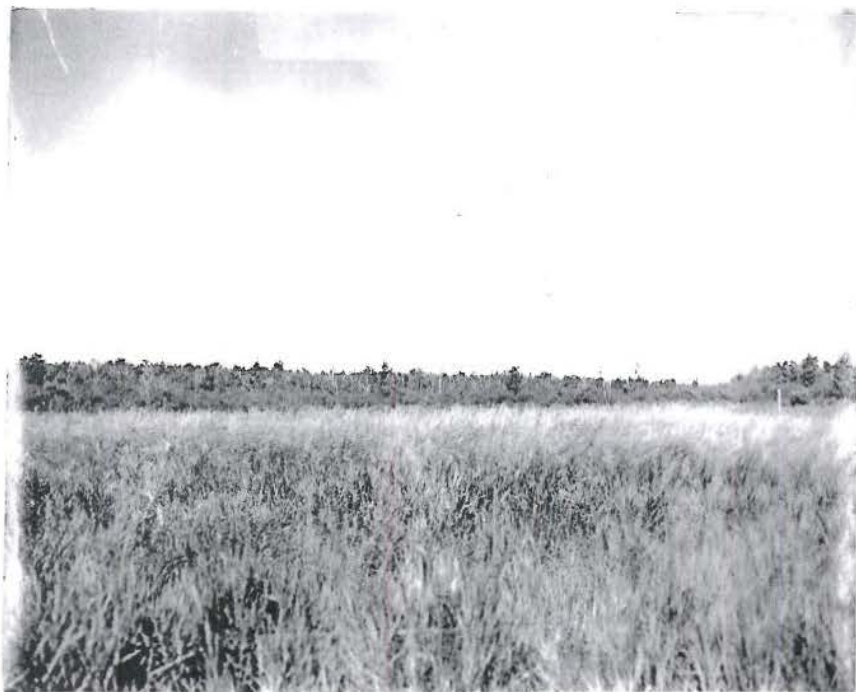
Figure 3

The flooded sweet gale along the edge of the stream appears to be in poor condition (see Fig. 20). In general sweet gale can grow in flooded waters, but the foliage which is water-covered dies rapidly (see Fig. 3).

Looking westward in a flooded grass-sedge marsh in Sed. 6.
Water level here, in July 1951, was less than one foot
of LA

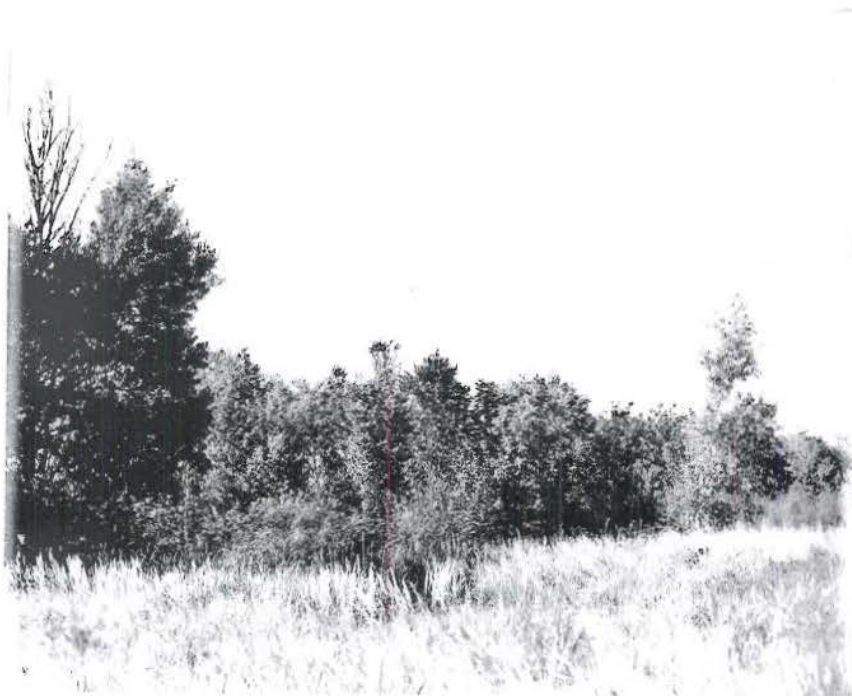
Figure 4

View of the same marsh showing, from foreground to back-
ground, sedge, reed, and grass, the sedge, the sedge
light foliage and sedge (dark foliage). 1951

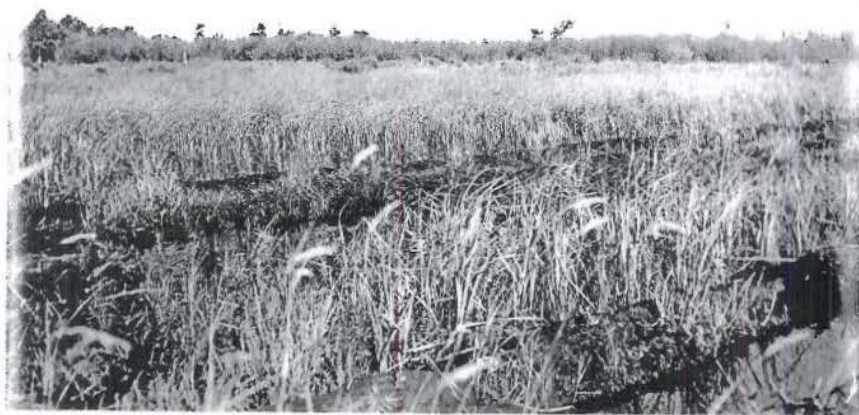
Figure 5

Experimental plowing in the same marsh as shown in
Figures 1 and 4. CP 2A

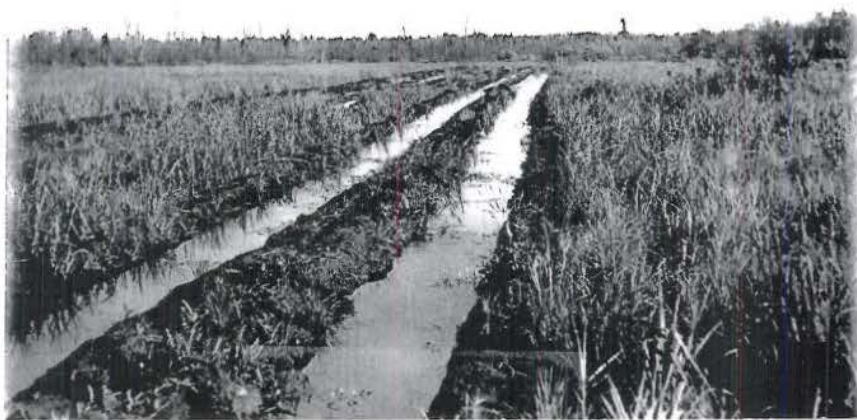
Figure 6

General view of experimental plowing. CP 2B

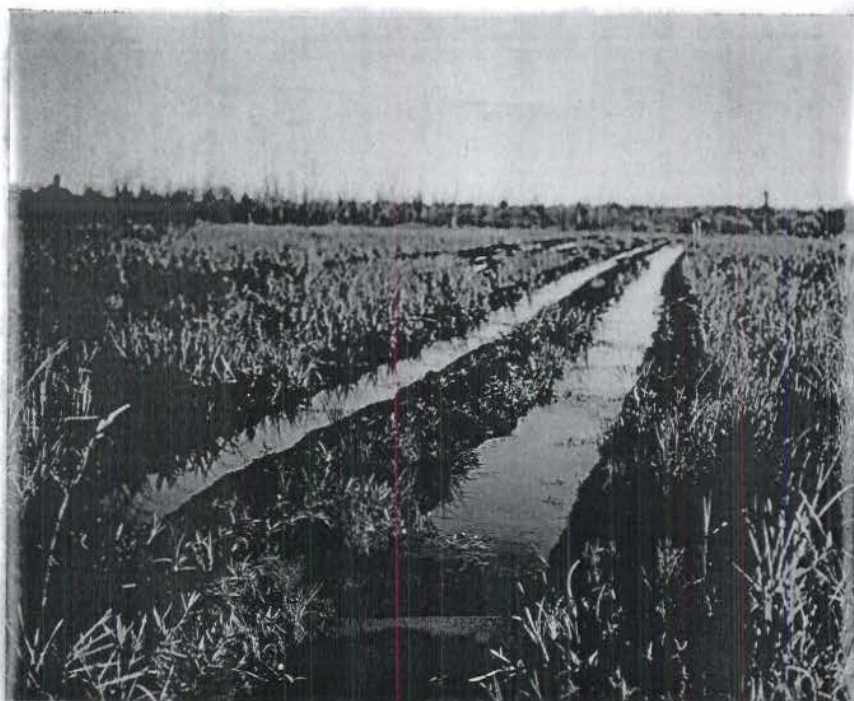
Figure 7
Bar reed and cattail (small shoots on ridges in foreground) establishing itself. Burbed is growing on the water's surface. CP 25

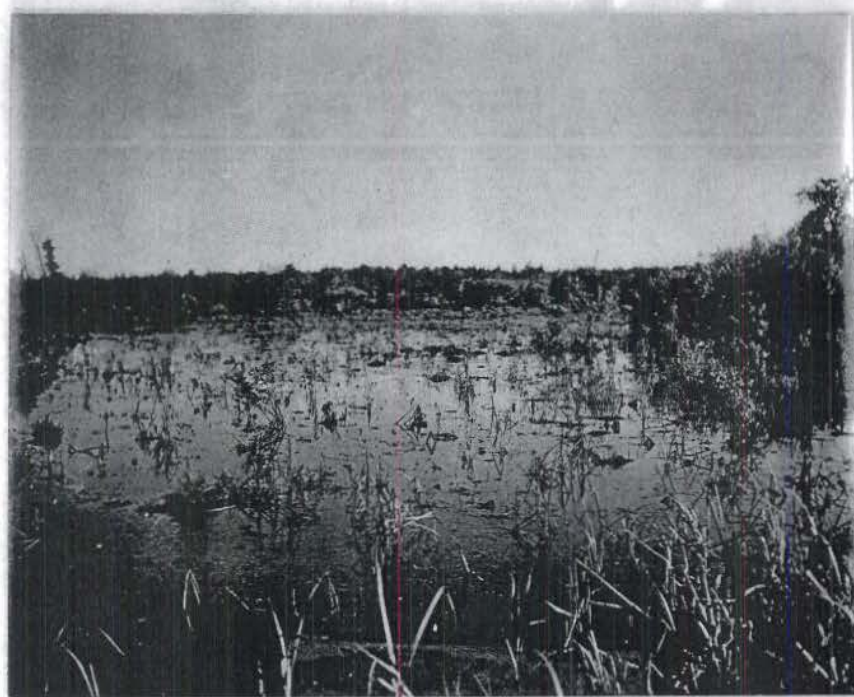
Figure 8
Flooded edge. Water depth here was 3 to 4 feet. CP 3A

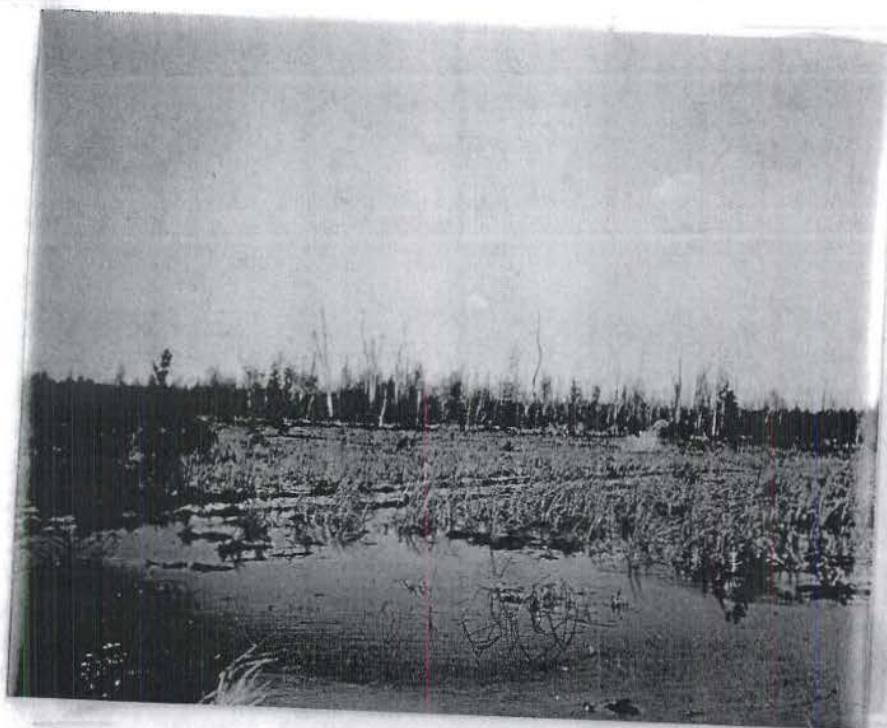
Figure 9
Flooded sedge; plowed stripes are seen across middle of
photo. CP 38

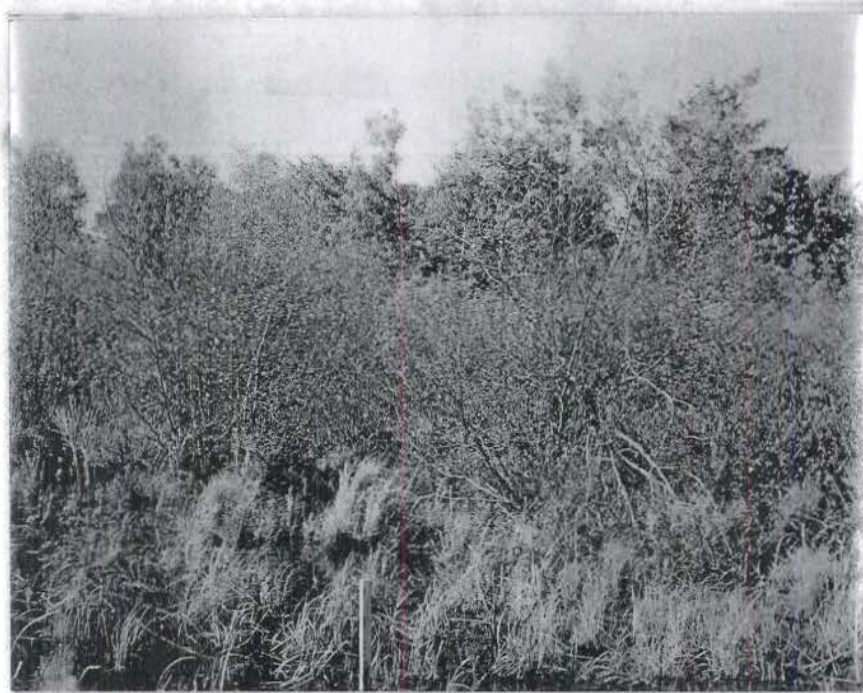
Figure 10
Flooded bog alder. Sedge in foreground and poplar in
background. The stake marks one of the herbicidal
plots. CP 39

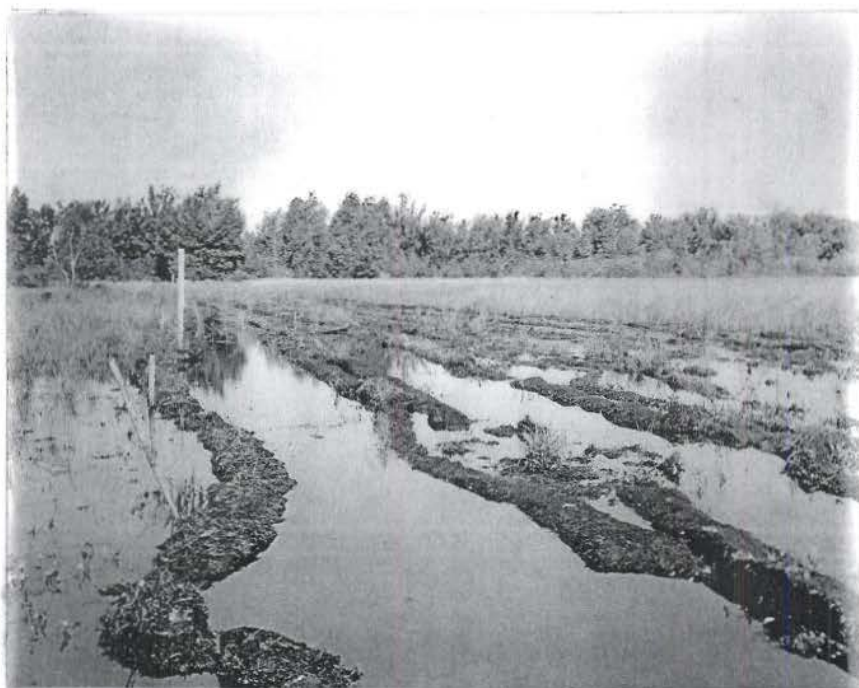
Figure 11
Successful elimination of sedge by plowing. Ducks have
used these ridges for loafing and preening. Note smart-
weed on water and on ridges. Stakes mark herbicidal
plots. CP 30

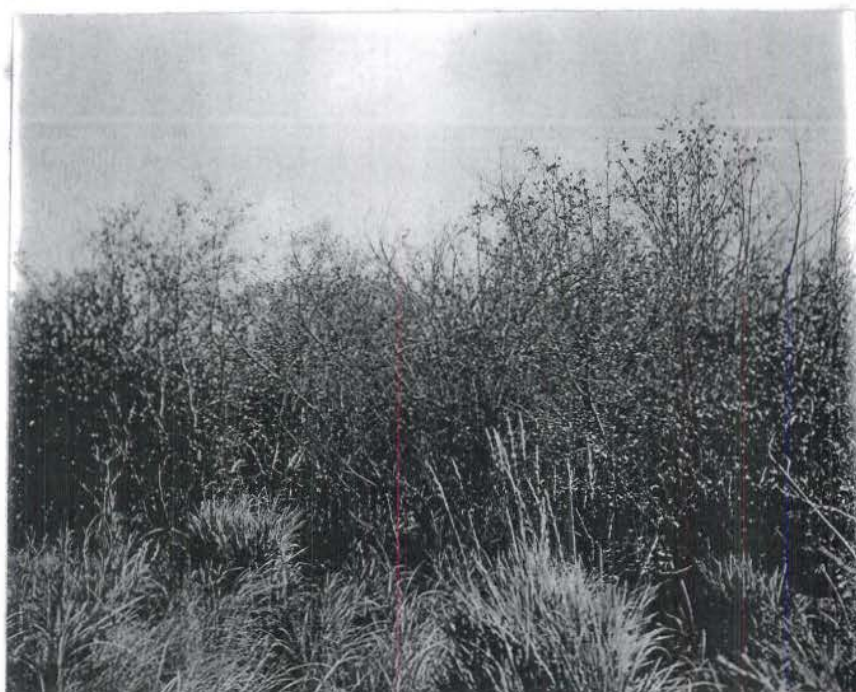
Figure 12
Flooded bog elder partially killed. CP 31

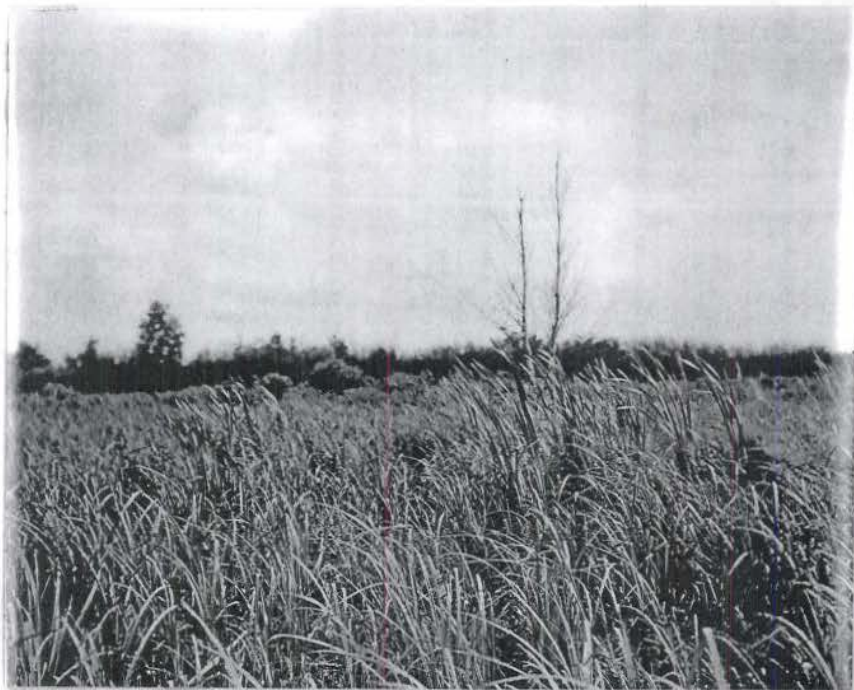
Figure 13
Cattail patches among sedge in flooded marsh. How will
flooding affect this cattail? CP 5A

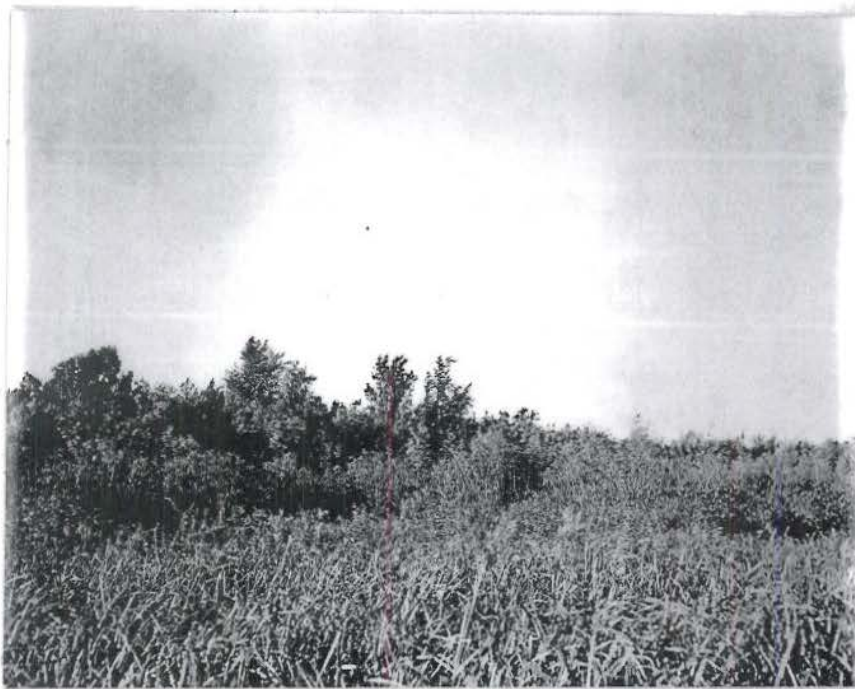
Figure 14
Edge of flooded sedge marsh showing, from foreground to
background, sedge, cattail, bog alder, and black ash. CP 5B

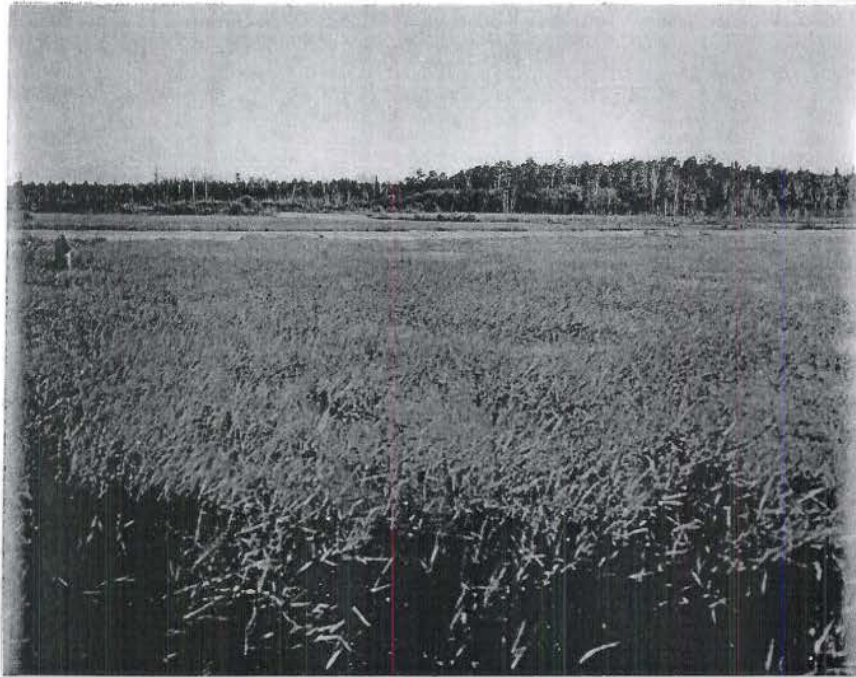
Figure 15
Flooded bluejoint in the stream basin. Note Bear Creek
across upper middle. CP 6A

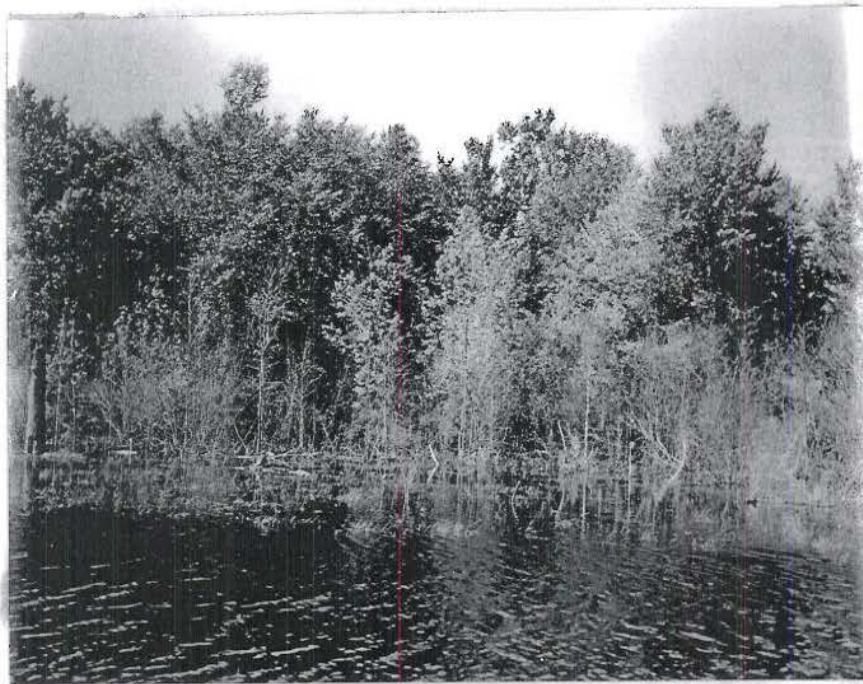
Figure 16
Looking from Bear Creek shoreward. From middle foreground
to background are seen bluejoint, black ash (small trees
with light foliage), elm, and red maple. CP 6B

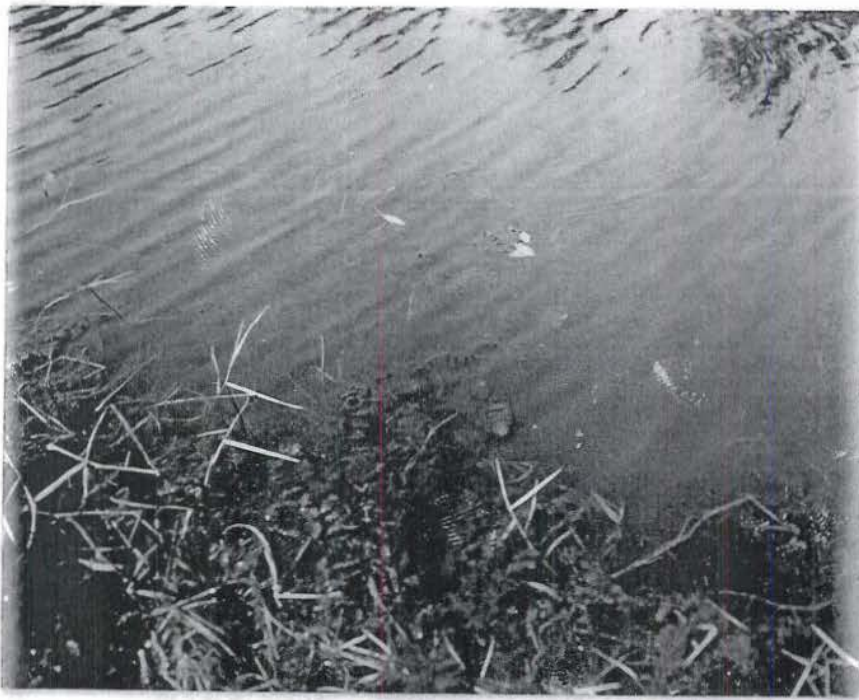
Figure 17

In the stream channel smartweed and bladderwort established themselves along the edges. Also along these edges, but with rarer occurrence, were found floating broadleaf (Fig. 17), flat-stemmed pondweed, coontail, and water arigold. It is believed that these plants were present before flooding. The great vigor with which these four plants can spread and dominate an area has been noted at older impoundments; the latter three are submerged types and no photographs are available.

Edge of stream channel, showing bluejoint, floating broadleaf (center of photo) and bladderwort (submerged). Will floating broadleaf take over this site, as it has done on other flooding projects? CP 62

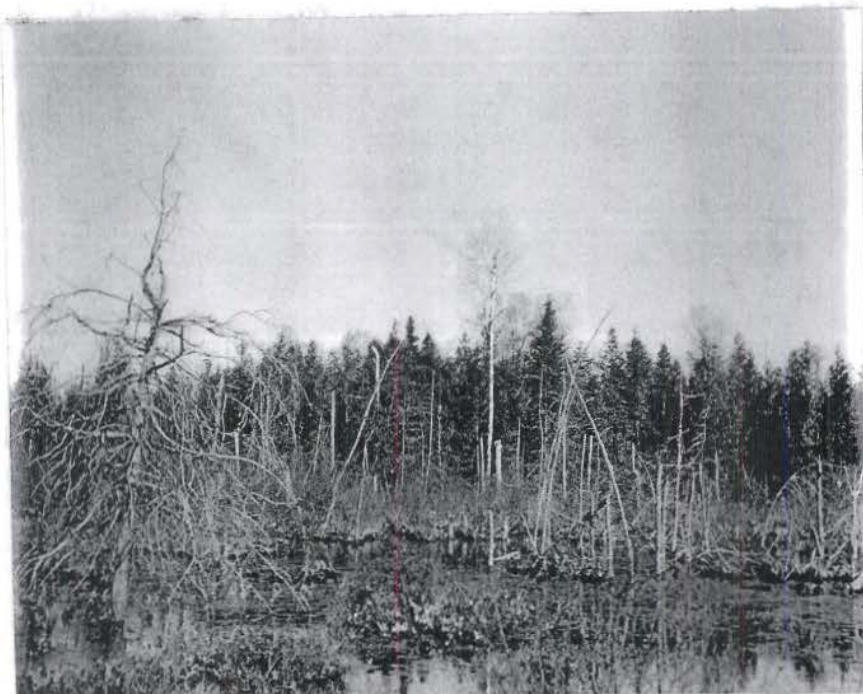
Figure 18

Cedar in background is standing in approximately one foot of water. Mounds in foreground give evidence of former floodings. Sweet gale (the low bushy plant in left foreground) is in poor condition. CP 7A

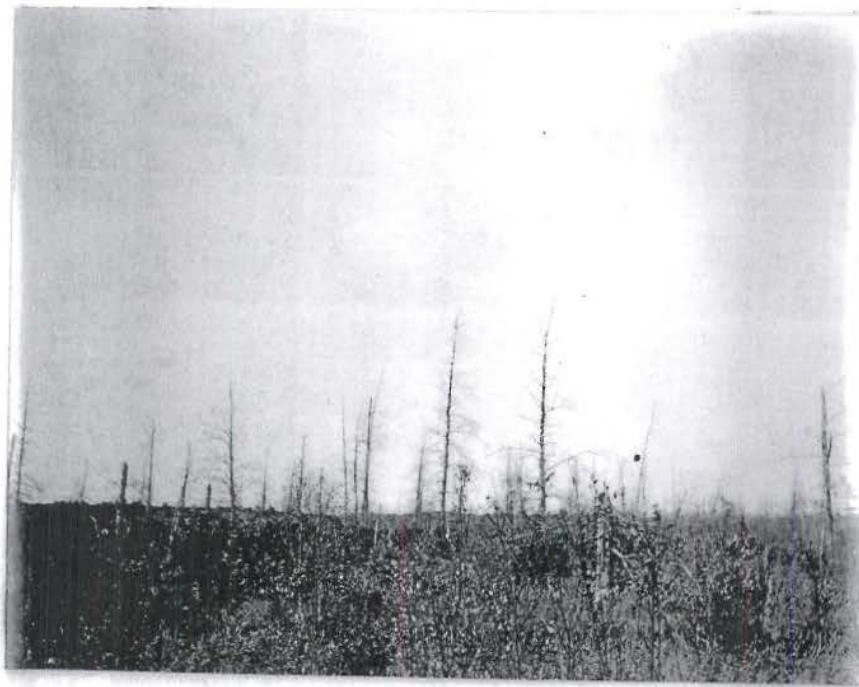
Figure 19
Flooded swampy birch (foreground). Cedar stumps are the
results of previous floodings. SP SA

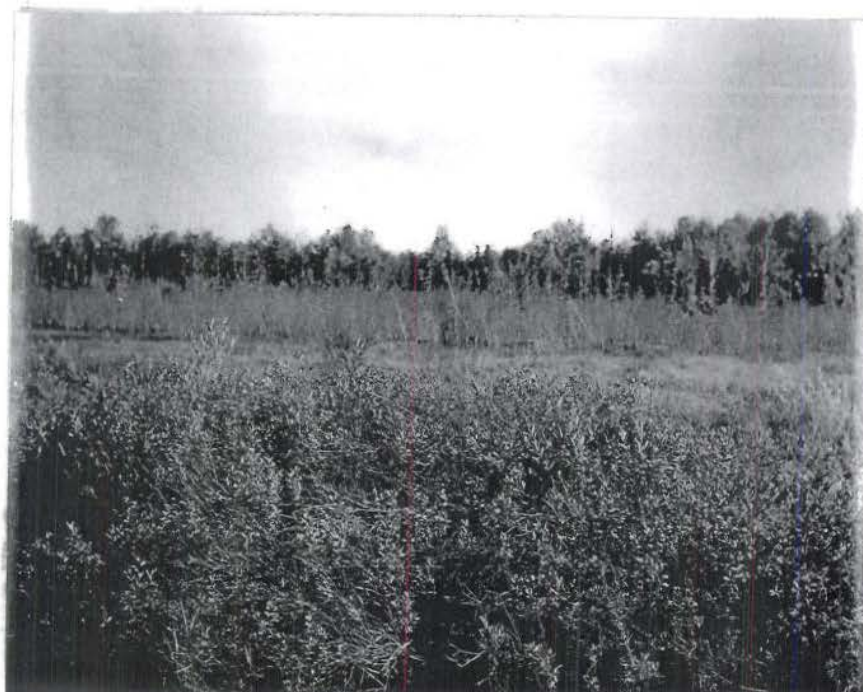
Figure 20
Flooded sweet gale; some willow is intermixed. SP SA

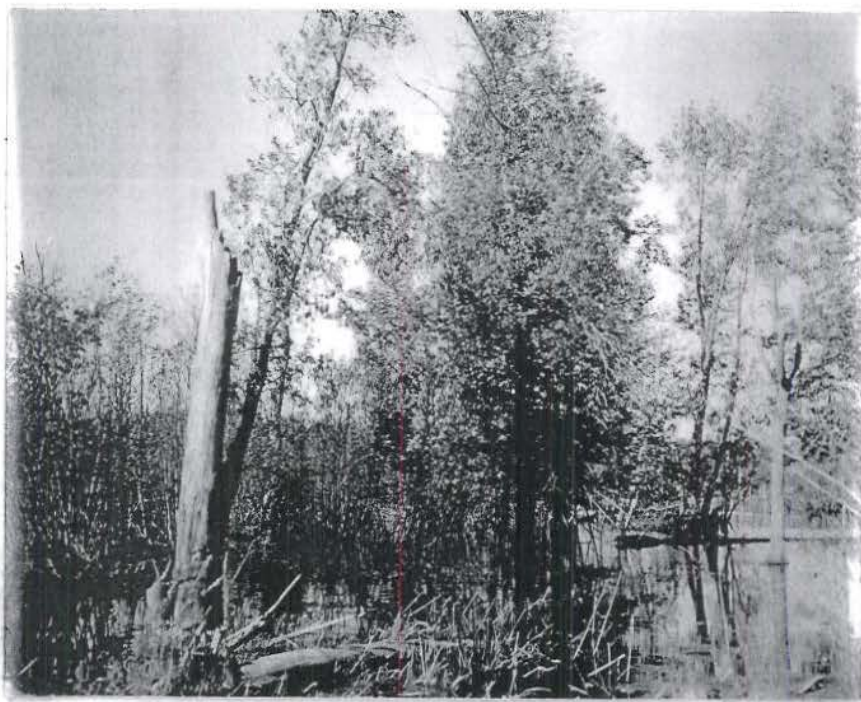
Figure 21

Flooded black ash (leaning tree), silver maple (center), and sag elder (extreme left). Dead trees indicate that former floods have killed some trees while others have survived. CP 9A

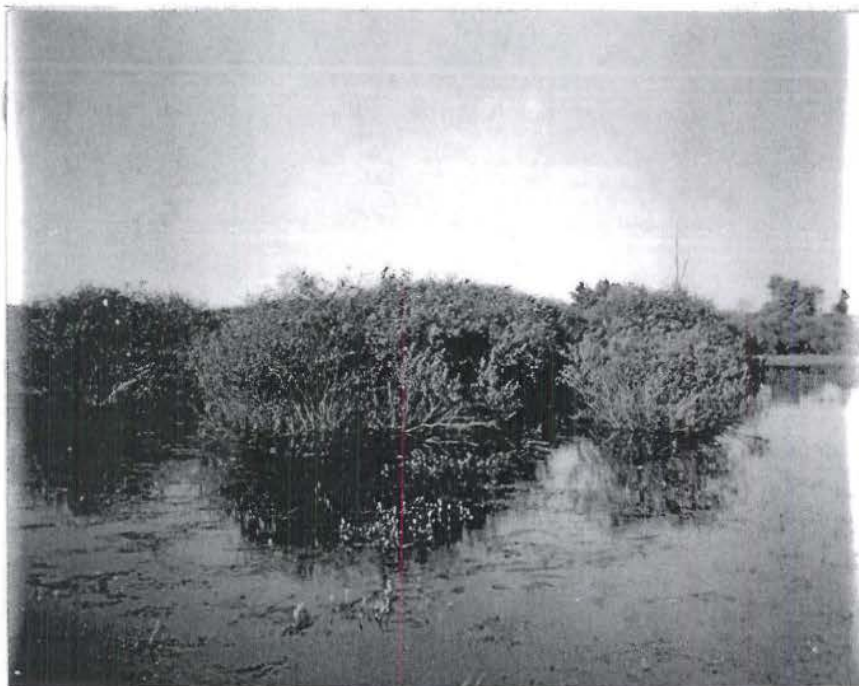
Figure 22

Flooded willows. Note the scumwood on the water surface. CP 10A

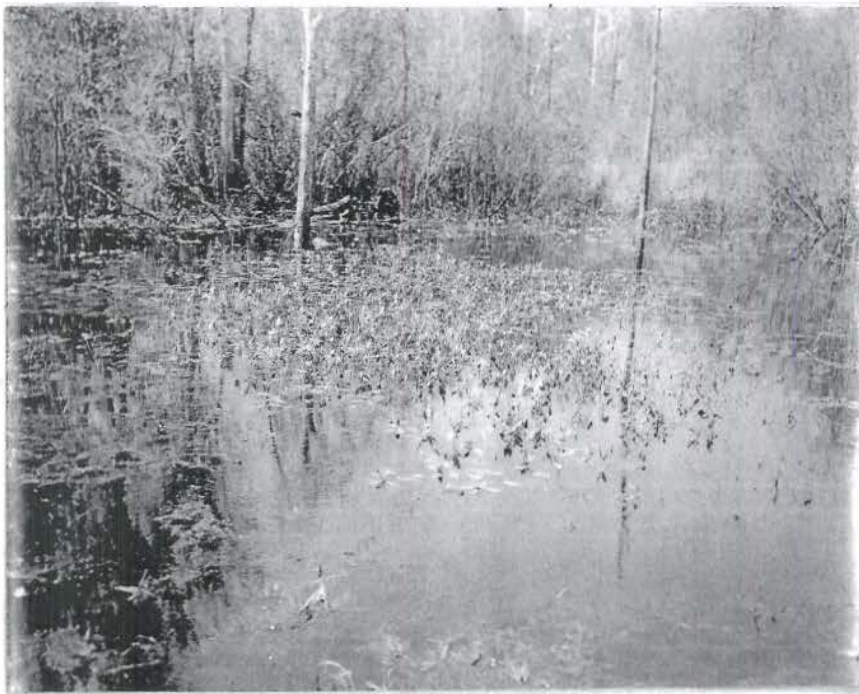
Figure 23
A dense smartweed patch that has appeared since flooding.
CP 11A

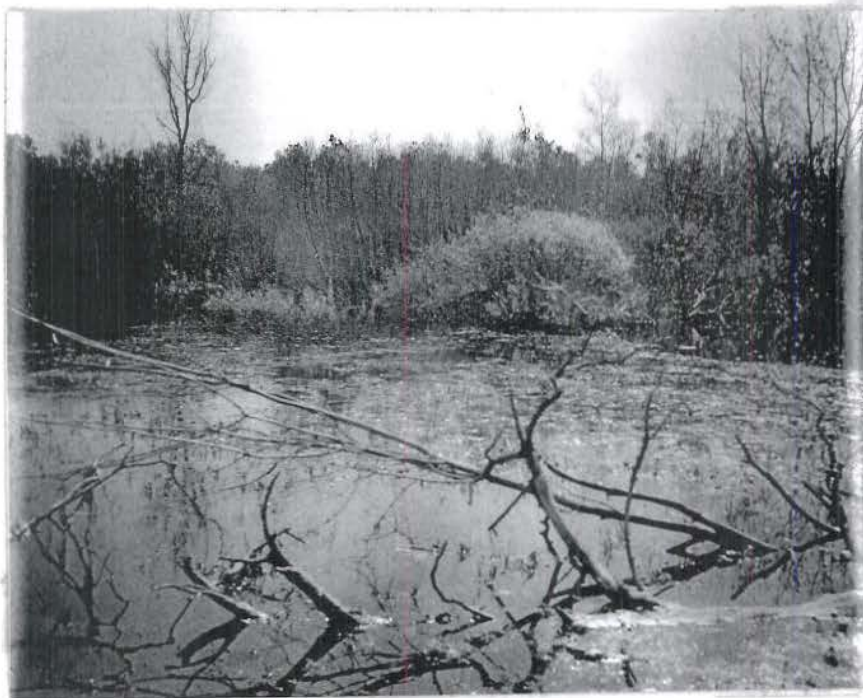
Figure 24
In the center of the figure is a clump of living willow
followed by a dense stand of dead bog alder killed by a
previous flooding. CP 11B

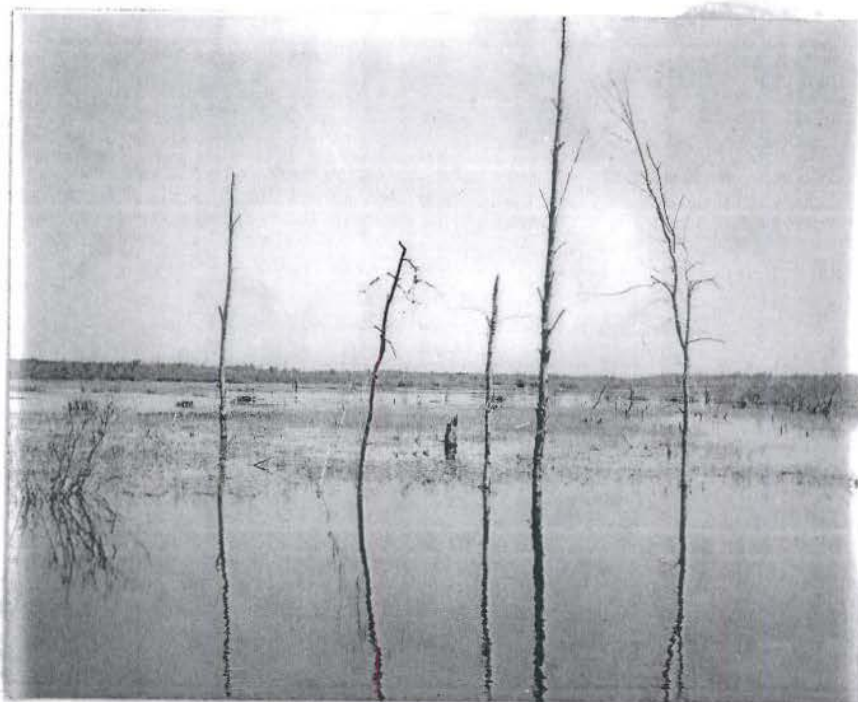
Figure 25
Looking southwest from near the dam. Dead trees mark the
edge of the stream channel. CP 118

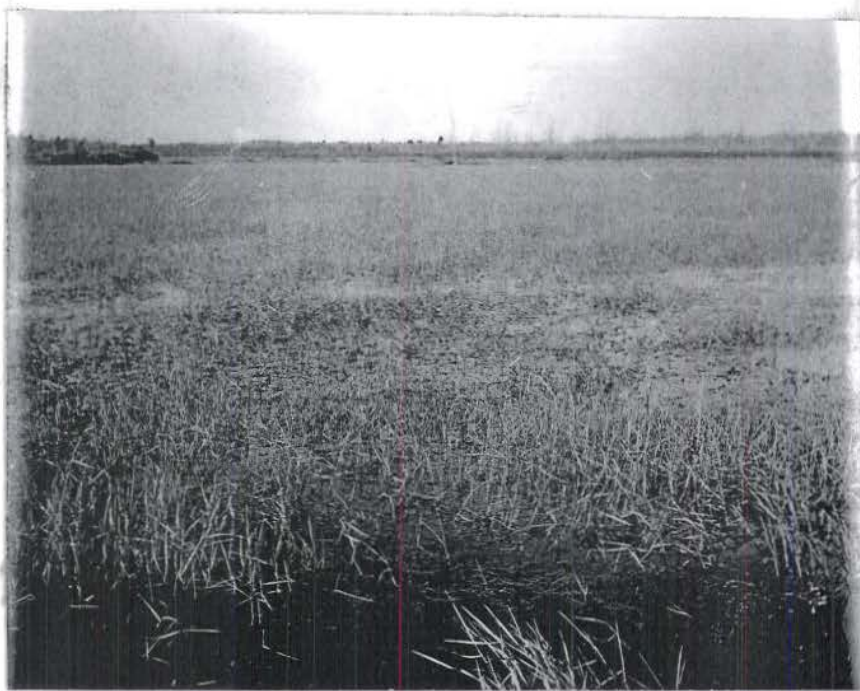
Figure 26
The most extensive region of flooded bluejoint on the area.
CP 124

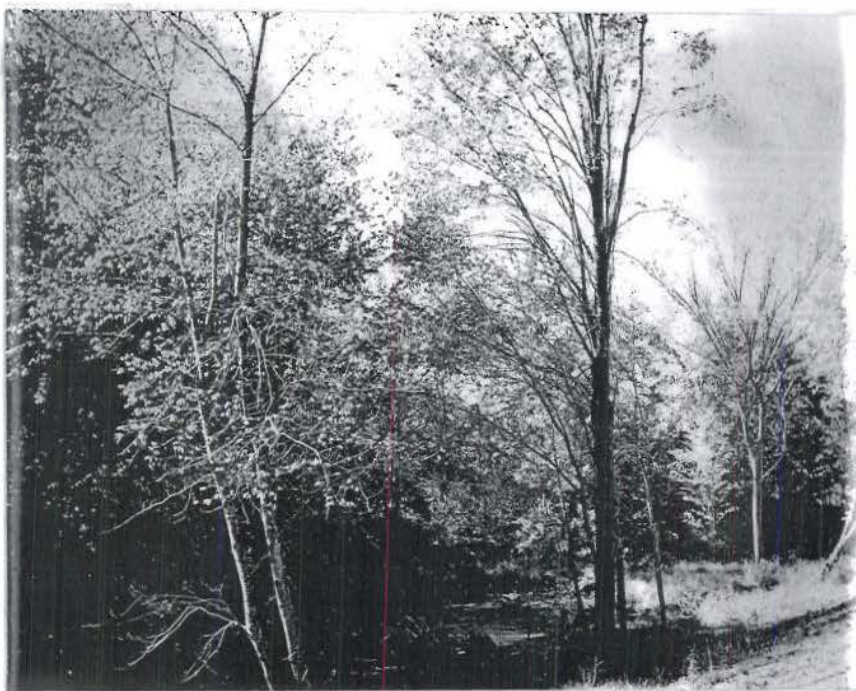
Figure 28

Hardwoods below the sand dike. CP 13a
